THE EFFECT OF COASTAL PROTECTIONS ON THE SHORELINE EVOLUTION AT KUALA NERUS, TERENGGANU (MALAYSIA)

MUHAMMAD SYAKIR ZUFAYRI ZULFAKAR¹, MOHD FADZIL AKHIR¹, EFFI HELMY ARIFFIN*^{1,2}, NOR ASLINDA AWANG³, MOHD AZAM MAT YAACOB¹, WEI SHENG CHONG¹ AND AIDY M. MUSLIM¹

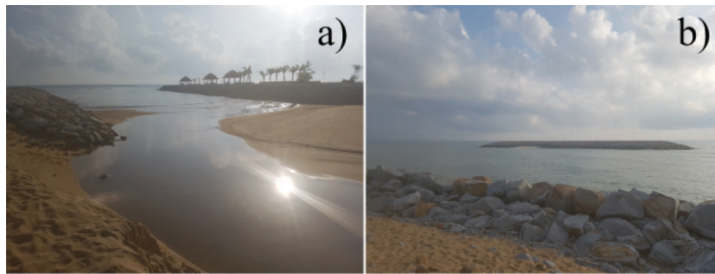
Studies on the influence of coastal protection structures are vital to determine whether the structures show positive or negative impacts towards the coastal dynamics. The coastal protection structures include the groyne, breakwater and revetment, built purposely to protect the shoreline. A groyne (Figure 1 (a)) is a structure built from the coastal shore or river

Figure 1: a) the groyne structure of Mengabang Telipot; b) The breakwater of Tok Jembal.

bank that interrupts the flow of water and limits the movement of sediment.

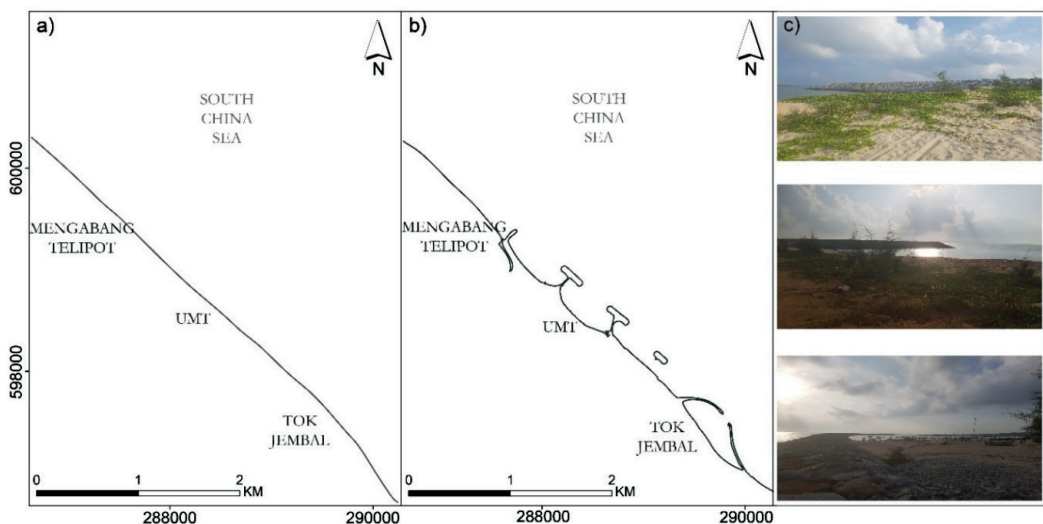
Figure 3 : Kuala Nerus beach; a) Shoreline of 2004; b) Shoreline of 2017 with the presence of breakwaters and groyne; c) Vegetation cover over the shoreline and tombolo of breakwater

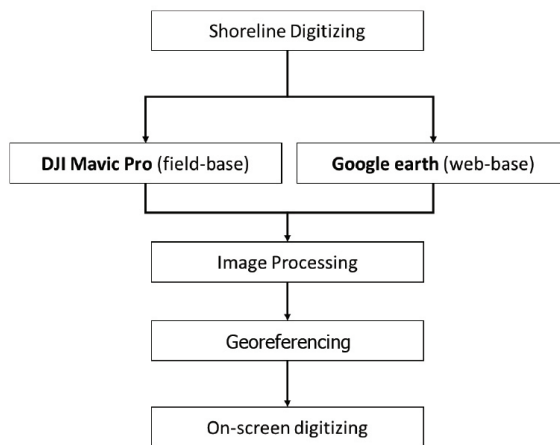
Figure 4 shows the flow chart of shoreline digitizing process from both UAV and GE images.

These images were combined and overlapped through mosaic technique using Photoscan from Agisoft LLC (Mancini *et al.*, 2013). After the mosaic and georeferencing processes were performed on the image, the digitizing process was replicated for each timeline. This study required a digital images or vector image for the statistical measurement by DSAS to estimate the rate of changes on Kuala Nerus shoreline. ArcGis 10.3 was used to digitize the raster images of shoreline into vector format of shape file data.

Figure 4: Extracting shoreline by using on-screen digitizing

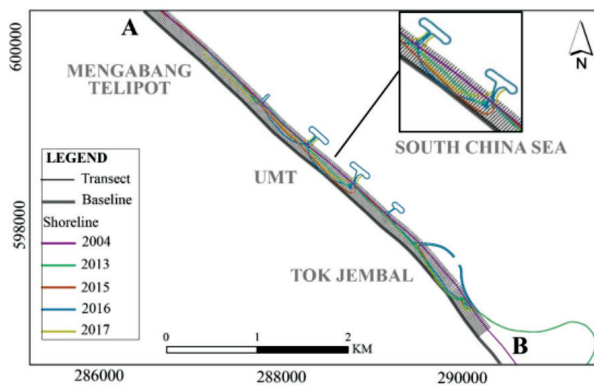
Digital Shoreline Analysis System (DSAS) was used as a medium to calculate the rate of the delineation changes of shoreline from 2004 until 2016 (2004-2016 model) and the changes between 2016 and 2017 (2016-2017 model). The extracted shorelines from GE and Mavic Pro were divided into 273 transects, as shown in Figure 4, that were oriented perpendicular

to the baseline with 20 m interval and 4 km length along the study area. In DSAS system, a baseline is needed to monitor the amount of shoreline changes on each transect. The baseline used the 2004 shoreline as reference with 170 m of width and 4 km of length. The baseline will be the reference line for each transect, where seaward shift of shoreline is considered as accretion, while landward shift is considered as erosion.

Figure 5: Transects line orientation layering on top of multiple shoreline years

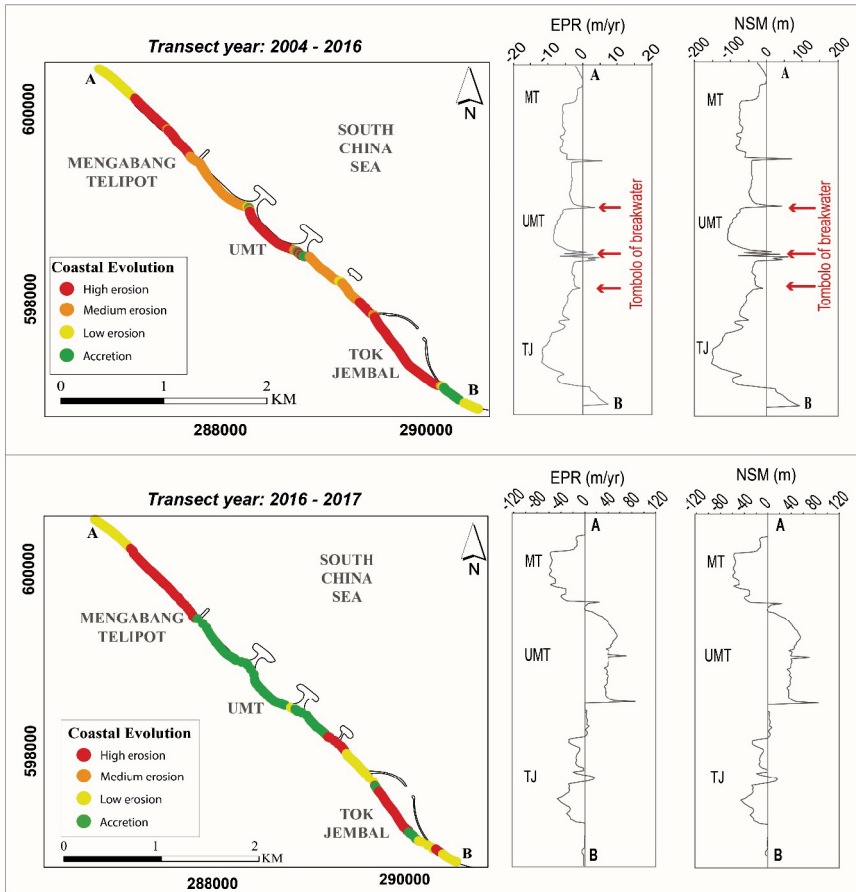
Through DSAS measurement, the EPR and NSM were used as statistical measure to identify the rate of the delineation changes over time. Overall, based on Figure 7 (upper), Kuala Nerus shoreline maximum retreat was -11 m/year and -150m of net shoreline changes for the period between 2004 and 2016, while the accretion occurred less than +5 m/year with net accretion of +94 m/year.

Tok Jembal: Pre-construction; the highest erosion rate was recorded within/on this beach especially in the bay area with approximately -10 m/year and net of -150 m eroded from 2004 until 2016. The only accretion is within the Tok Jembal southernmost beach with accretion less than +5 m/year net. Post-construction; mixed results were recorded within the bay of semi enclosed groyne (jetty groyne) at Tok Jembal. Erosion occurred in the middle of the bay with -40 m movement directly facing the opening between the two groynes although some accretion occurs within the bay. The accretion rate was up to 20 m a year within this area.

UMT: During pre-construction; the highest accretion rate is less than +5 m/year, where the accretion was seen on the formation of tombolo that naturally formed behind the face of breakwaters. This can be seen in the front of the UMT beach. Although there were formations of tombolo behind the breakwater, the UMT beach was showing significant erosion rate of -8 m/year and -110 m of net movement of shoreline. During post-construction; the shore of UMT showed positive result, marked with the green line indicating positive value showing accretion event recorded at more than 20 m in one year. The statistical measurement by DSAS shows that the UMT shore was gaining an accretion up to +80m over one year of movement.

Figure 7: Upper column shows shoreline changes rate between 2004 until 2017 (pre-construction) while lower column shows the rate of shoreline changes between 2016 and 2017 (post-construction)

Mengabang Telipot: Pre-construction, the erosion rate at Mengabang Telipot shore was -6 m/year and -80 m of net shoreline movement and wider area eroded as there were no coastal protection structures until recently. On transect 2: the shore retreated at the rate of -50 m over a year timeline. Based on the transect pattern, the northern area was having a high erosion rate ranging between -20 m/year to -40 m/year in one year.

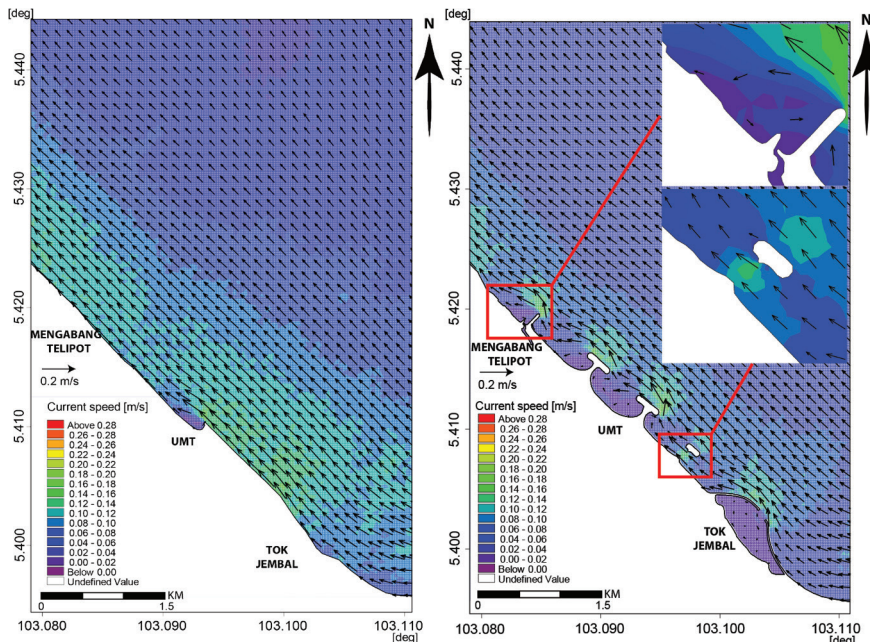
Figure 8 illustrates the current moving northward with the speed ranging from 0.06 m/s to 0.20 m/s in 2014 when the coastal protection structure was still not built. The shore is perceived to receive stronger current movement during the period as compared to 2017 where the coastal protection structure was in place. The shoreline received less impact in 2017 since the incoming current had been slowed down and altered by the coastal protection structure, especially at Tok Jembal and UMT beaches. A current recirculation can be seen in the lee of the coastal protection structure. The recirculation is observable on the left side of the breakwater in front of UMT’s beach with current speed below 0.02 m/s.

Figure 8: Current Speed during 2014 (left) and 2017 (right)

Although the current might have slowed down in most area, some area still received high current speed as shown in Figure 8 (right) with two areas experienced strong movement. Although there was no recirculation observed, the current passing through the curved groyne of Tok Jembal directly hit the near shore area, causing the disappearance of tombolo features behind the southernmost breakwater. As for the groyne of Mengabang Telipot, the current deflected caused recirculation on the shore side.

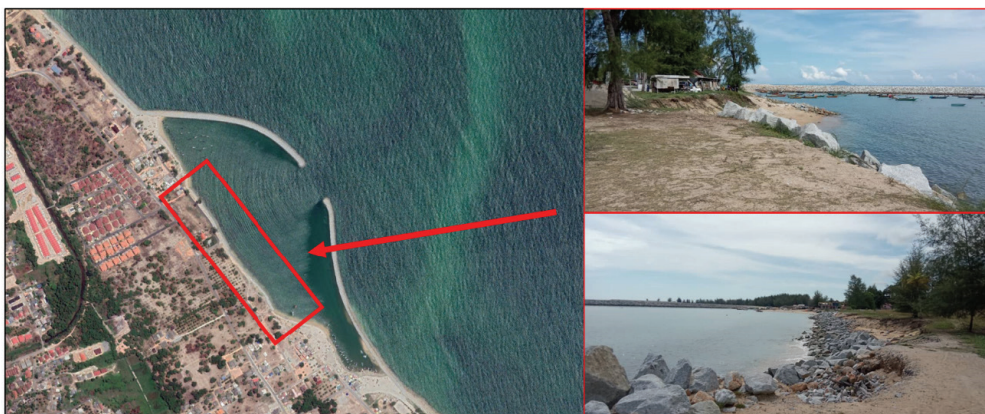
Post-construction (2017): The constructed structure seems to reduce the intensity of incoming current. However, the structures also caused the formation of recirculation current, which led to the formation of rip current which has the possibility of driving sediment transport beyond the surf zone (Pattiaratchi *et al.*, 2009; Scott *et al.*, 2016), which in turn, limits the sediment supply to the shore. On north part of Mengabang Telipot the presence of recirculation current in the lee of the groyne might explain the heavy erosion in the area. Another re-circulation current is seen inside the jetty groyne with clockwise circulation representing an embayed circular rips current (Castelle *et al.*, 2016). The embayed-circular rips formed in an embayed beaches is associated with shore erosion, especially with occurrence of storm event (Loureiro *et al.*, 2011). As shown in Figure 9, despite having revetment structure, the shore

Figure 9: The jetty groyne of Tok Jembal facing shore erosion despite having revetment protection

had been eroded due to the re-circulation current with around -20 m/year have been eroded between 2016 and 2017.

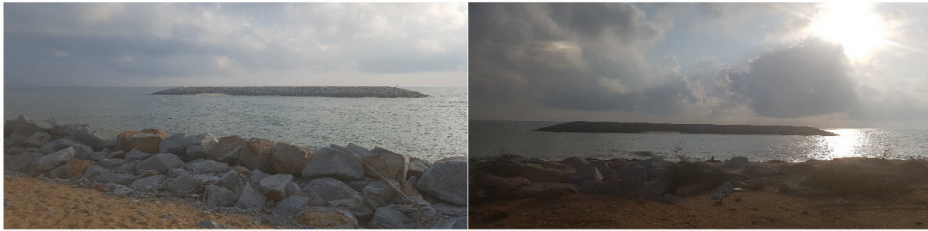
Figure 10: Revetment on the shore of Tok Jembal, with offshore breakwater on the middle of water
